Asphalt-Fiberglass for Precipitation Catchments

Author(s): Lloyd E. Myers and Gary W. Frasier

Source: *Journal of Range Management*, Vol. 27, No. 1 (Jan., 1974), pp. 12-15

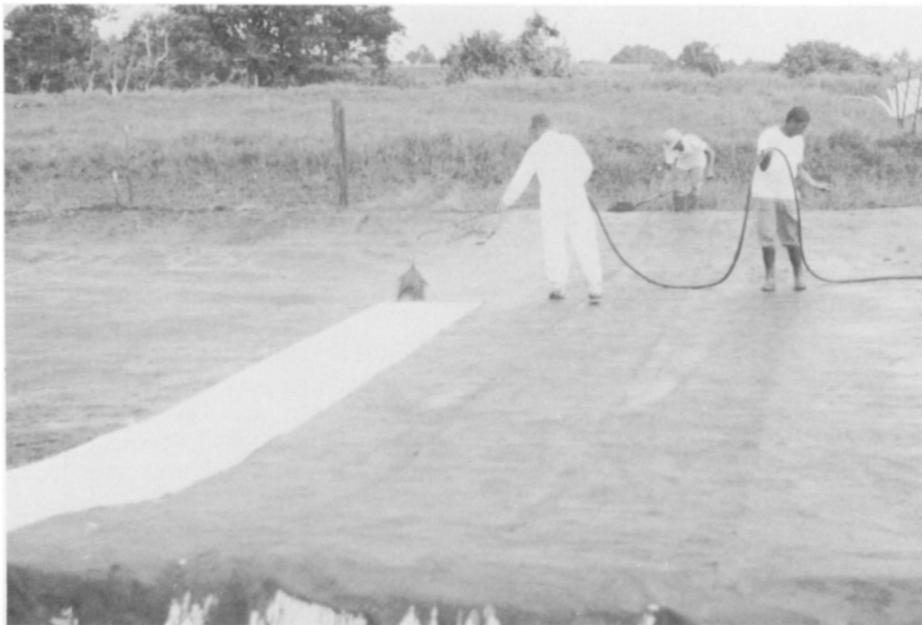
Fig. 4. Laying the fiberglass mat and spraying with asphalt emulsion.

bonded into a continuous mat 36 to 72 inches wide with a polyester resin sizing which softens when treated with asphalt. Starting on the lower berm of the catchment, the fiberglass is unrolled in a strip transverse to the slope with the lower edge extending into the bottom of the anchor trench. The ends of this fiberglass strip and subsequently laid strips must also extend into the side trenches. Care should be taken to avoid wrinkles. The fiberglass is then coated with 1/2 to 3/4 gal of asphalt emulsion per square yard to saturate the mat and bond it to the underlying soil as shown in Figure 4. Both cationic and anionic emulsions with 60% solids have proved satisfactory for this base coat. The asphalt can be applied with standard gear pump asphalt spray equipment, or it can be poured on the fiberglass from buckets and spread with soft-bristled industrial floor brooms. After the first fiberglass strip is coated, the next strip is unrolled, overlapping the first strip about 4 inches, and coated with asphalt. This procedure is continued up the slope until the entire catchment is covered. The asphalt emulsion softens the sizing in the matting, allowing it to conform to minor irregularities in the catchment surface within a few hours. Immediately after this base coat is applied, the trenches around the catchment are partially backfilled to prevent wind from damaging the covering before the asphalt sets and hardens.

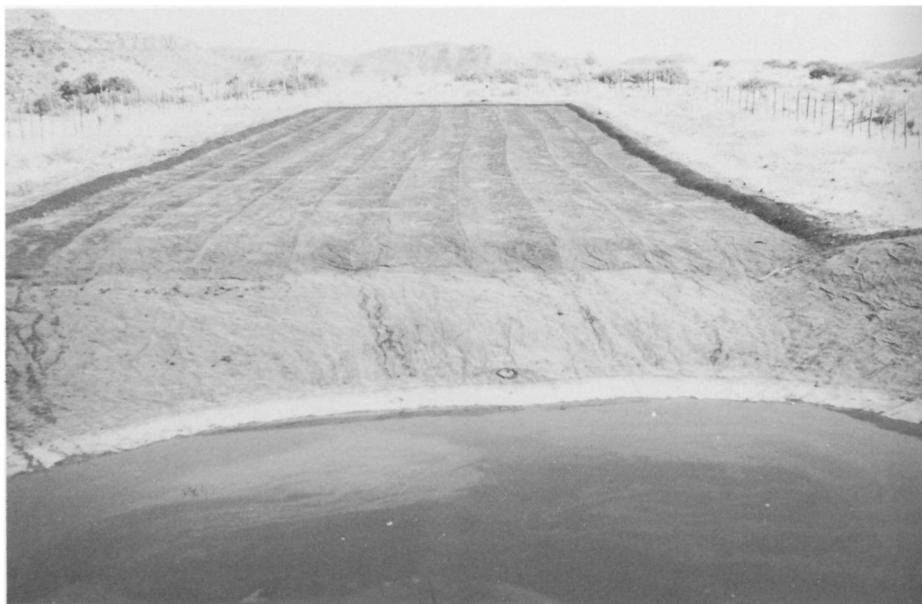
Fig. 5. Completed asphalt-fiberglass lined catchment and reservoir on Fort Apache Indian Reservation.
